Cast/Ductile Iron Water Mains: Recovery Plan for Decades of Underfunding

Optimization Strategies to Extend the Life of Cast and Ductile Iron

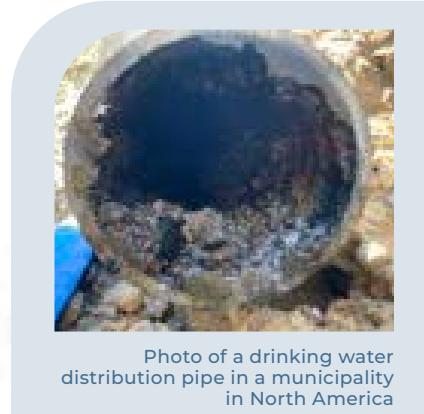
Photo of a drinking water distribution pipe in a municipality in North America

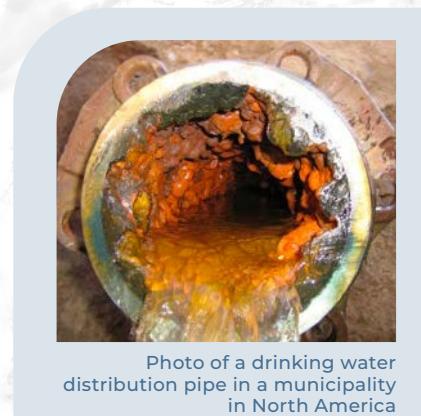
Photo of a drinking water distribution pipe in a municipality in North America

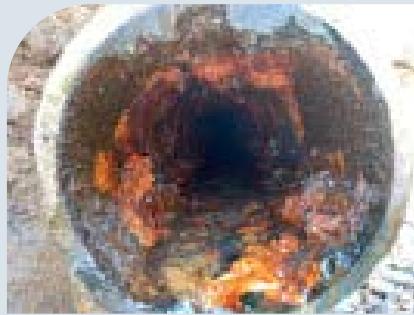
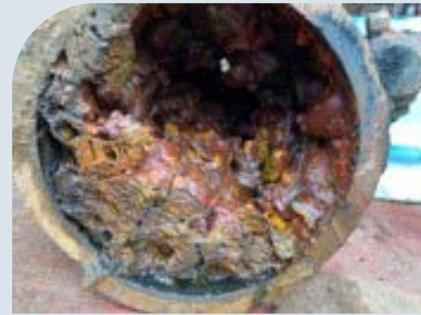
Photo of a drinking water distribution pipe in a municipality in North America

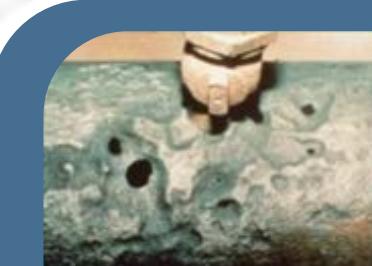
Photo Matergenics

For example, a brass service connection (potential: -0.370 V) coupled with a cast iron main (-0.500 V) will cause corrosion of the cast/ductile iron, which donates its electrons to the brass. Over time, this process progressively weakens the integrity of the network.

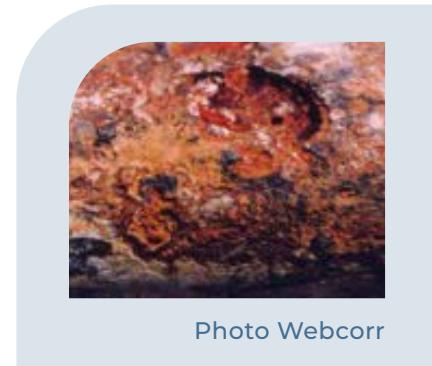
Stray currents can originate from various electrical infrastructures (see graphic below), including railways, high-voltage power lines, cathodic protection systems for gas networks, industrial facilities, and other nearby installations.

Potential Sources Of Stray Currents Affecting Cast/Ductile Iron Water Mains

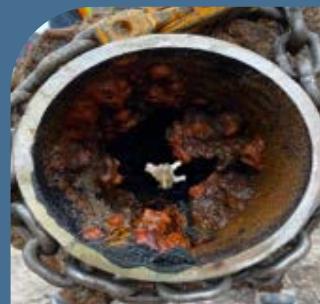
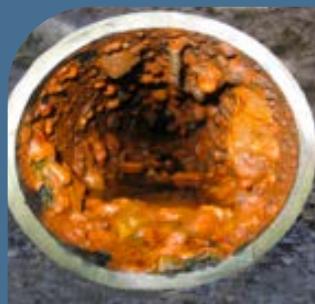
**No external corrosion
— only internal
corrosion.**
